**APRIL 2015**

**Conlegno**

**Quality monitoring analysis of UIC pallets**

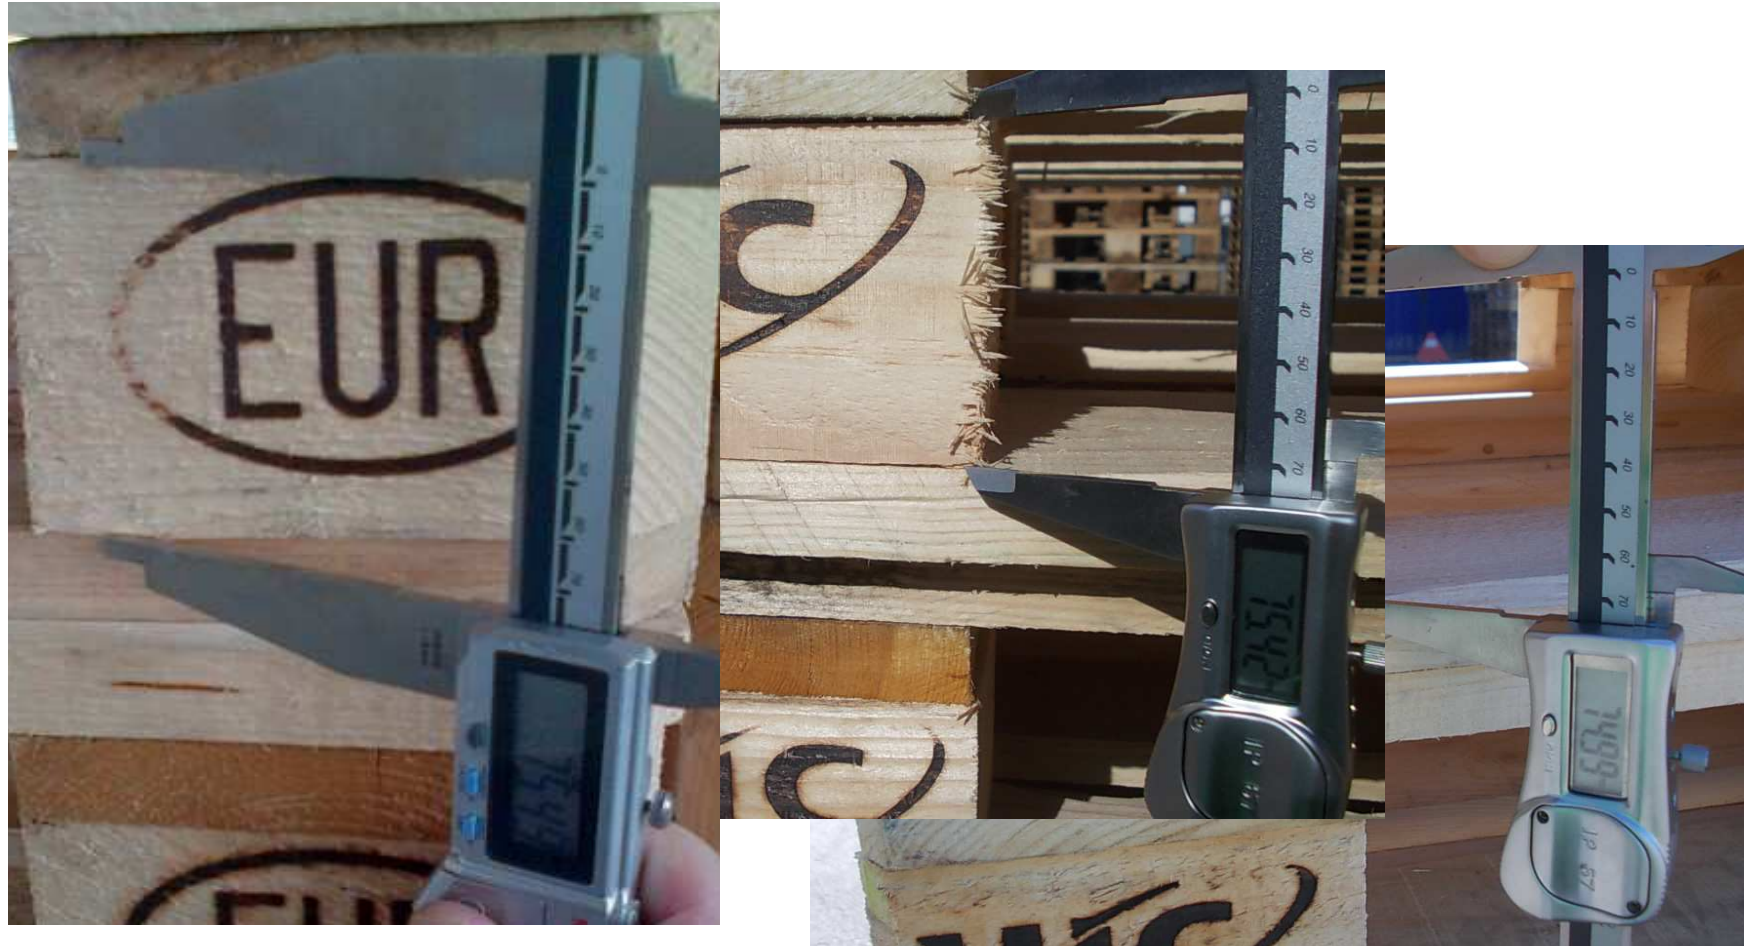
**Correct block height 78 mm**

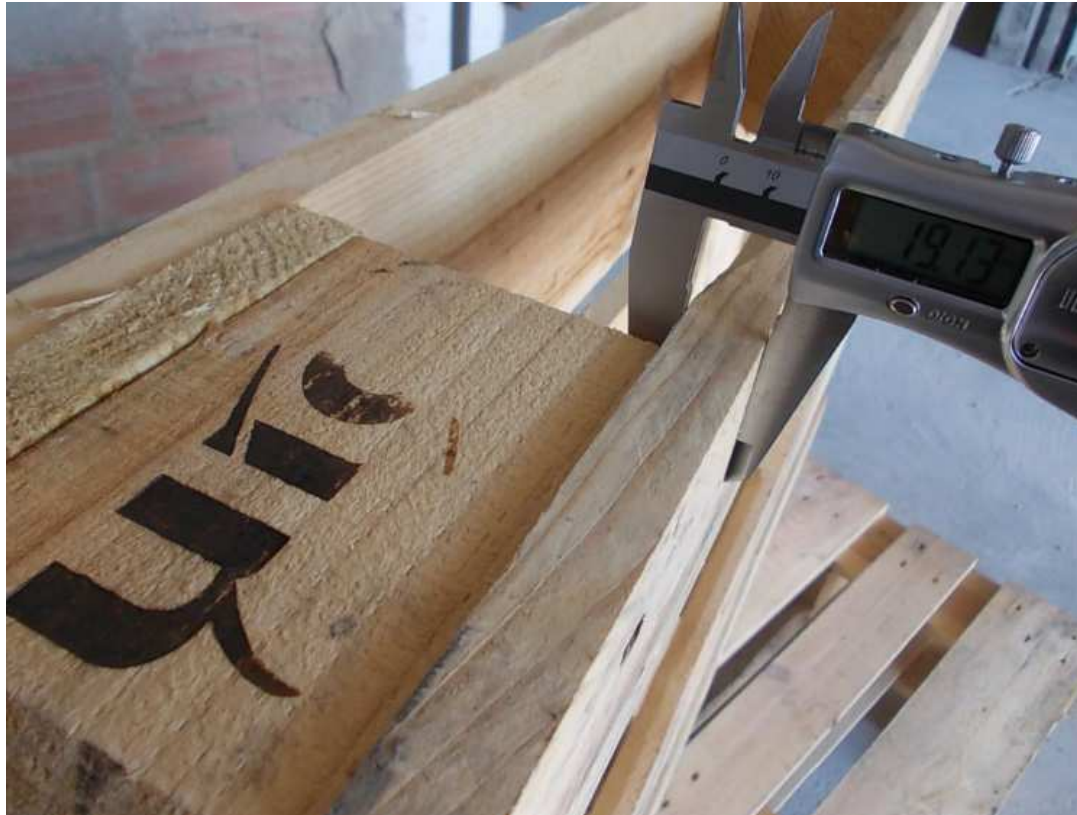
**Correct board thickness 22 mm**

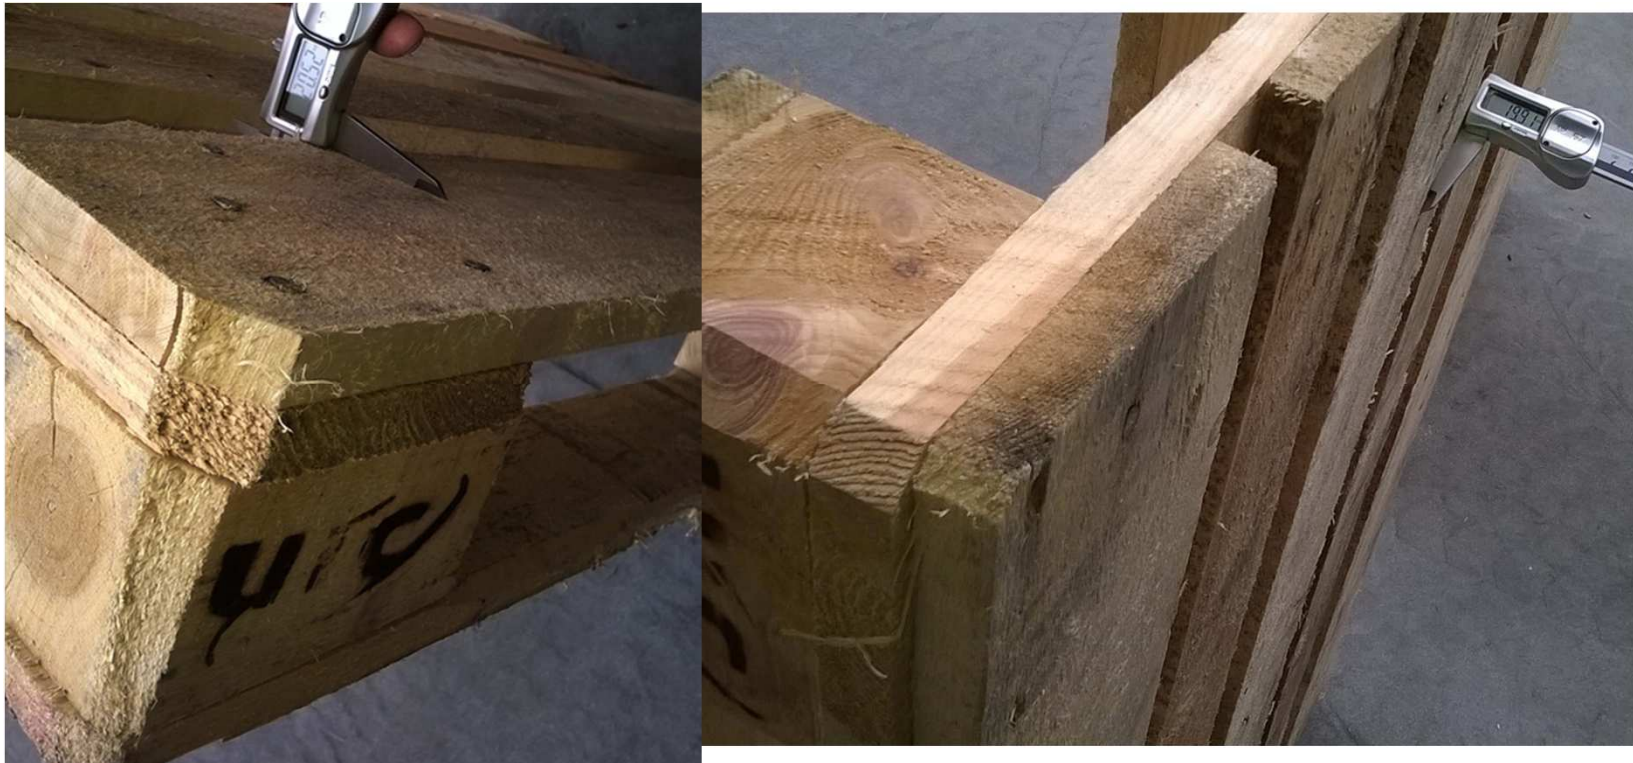
**Correct board thickness 22 mm**

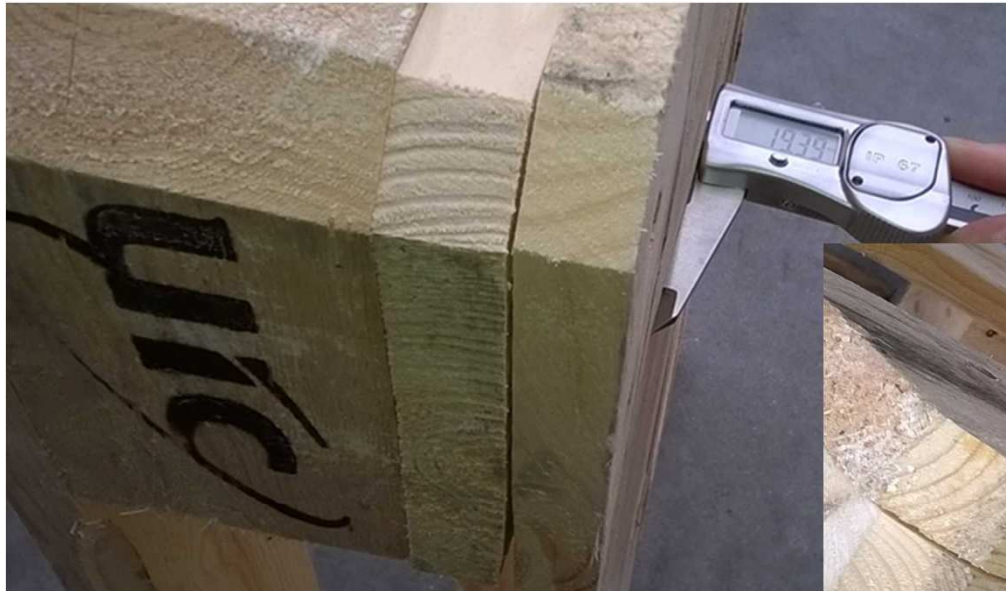
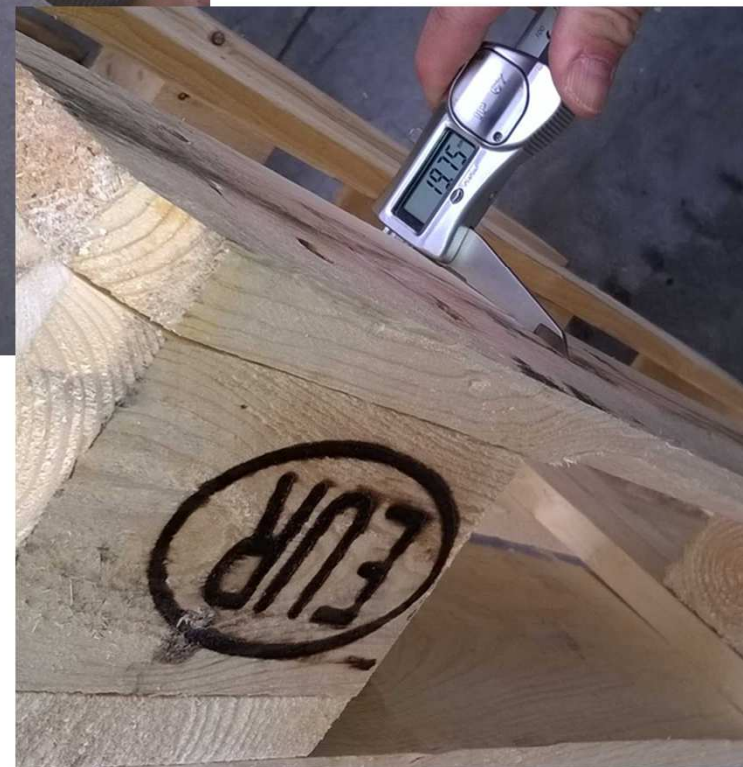
**Correct board thickness 22 mm**

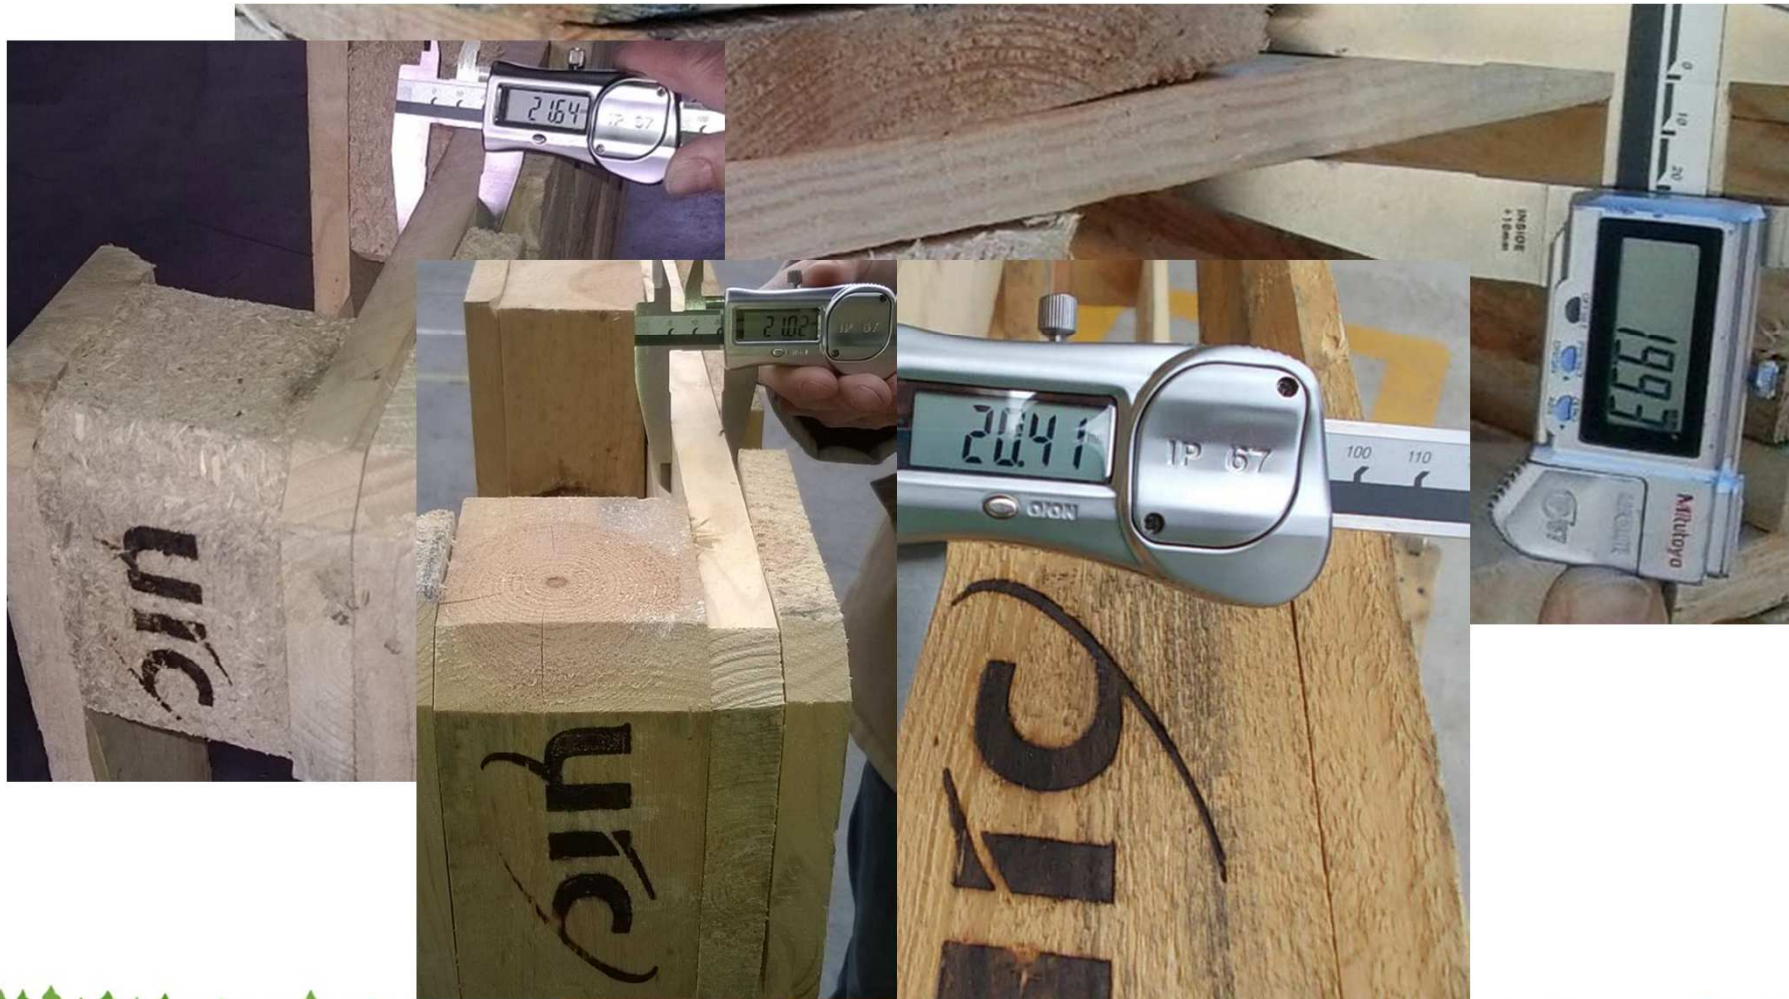
**Correct board thickness 22 mm**

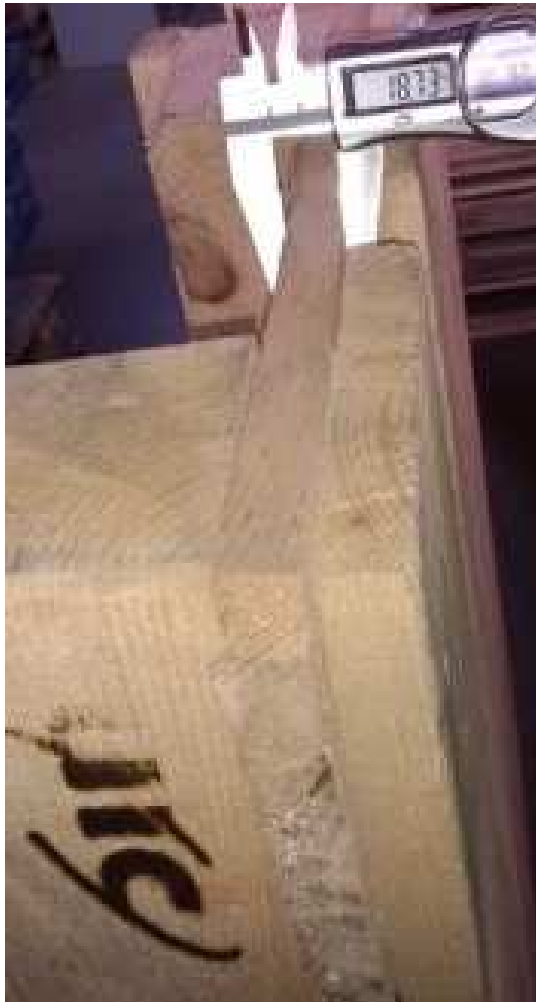
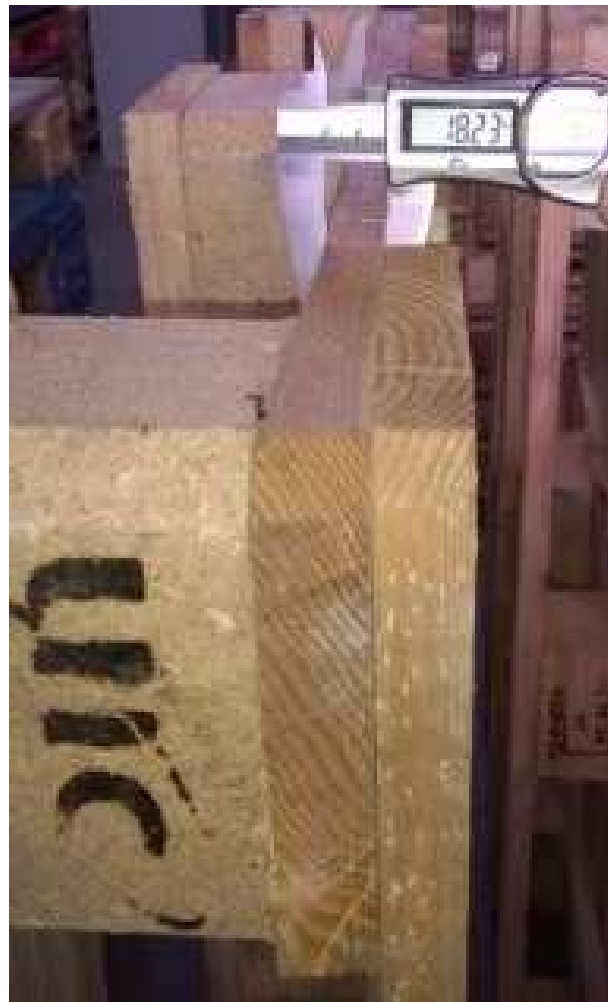
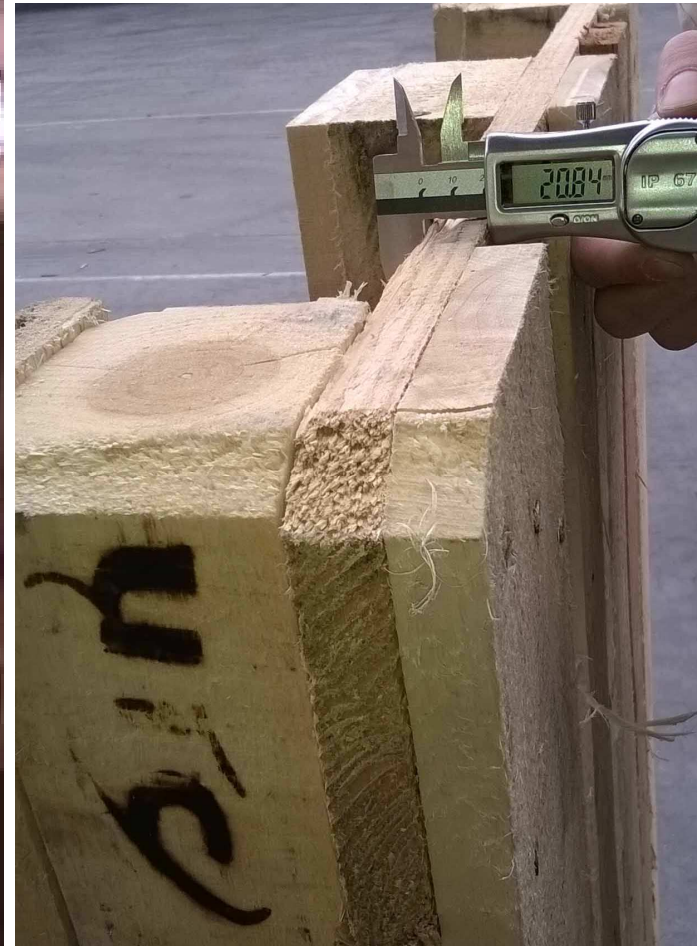
**Correct cross board thickness 22 mm**

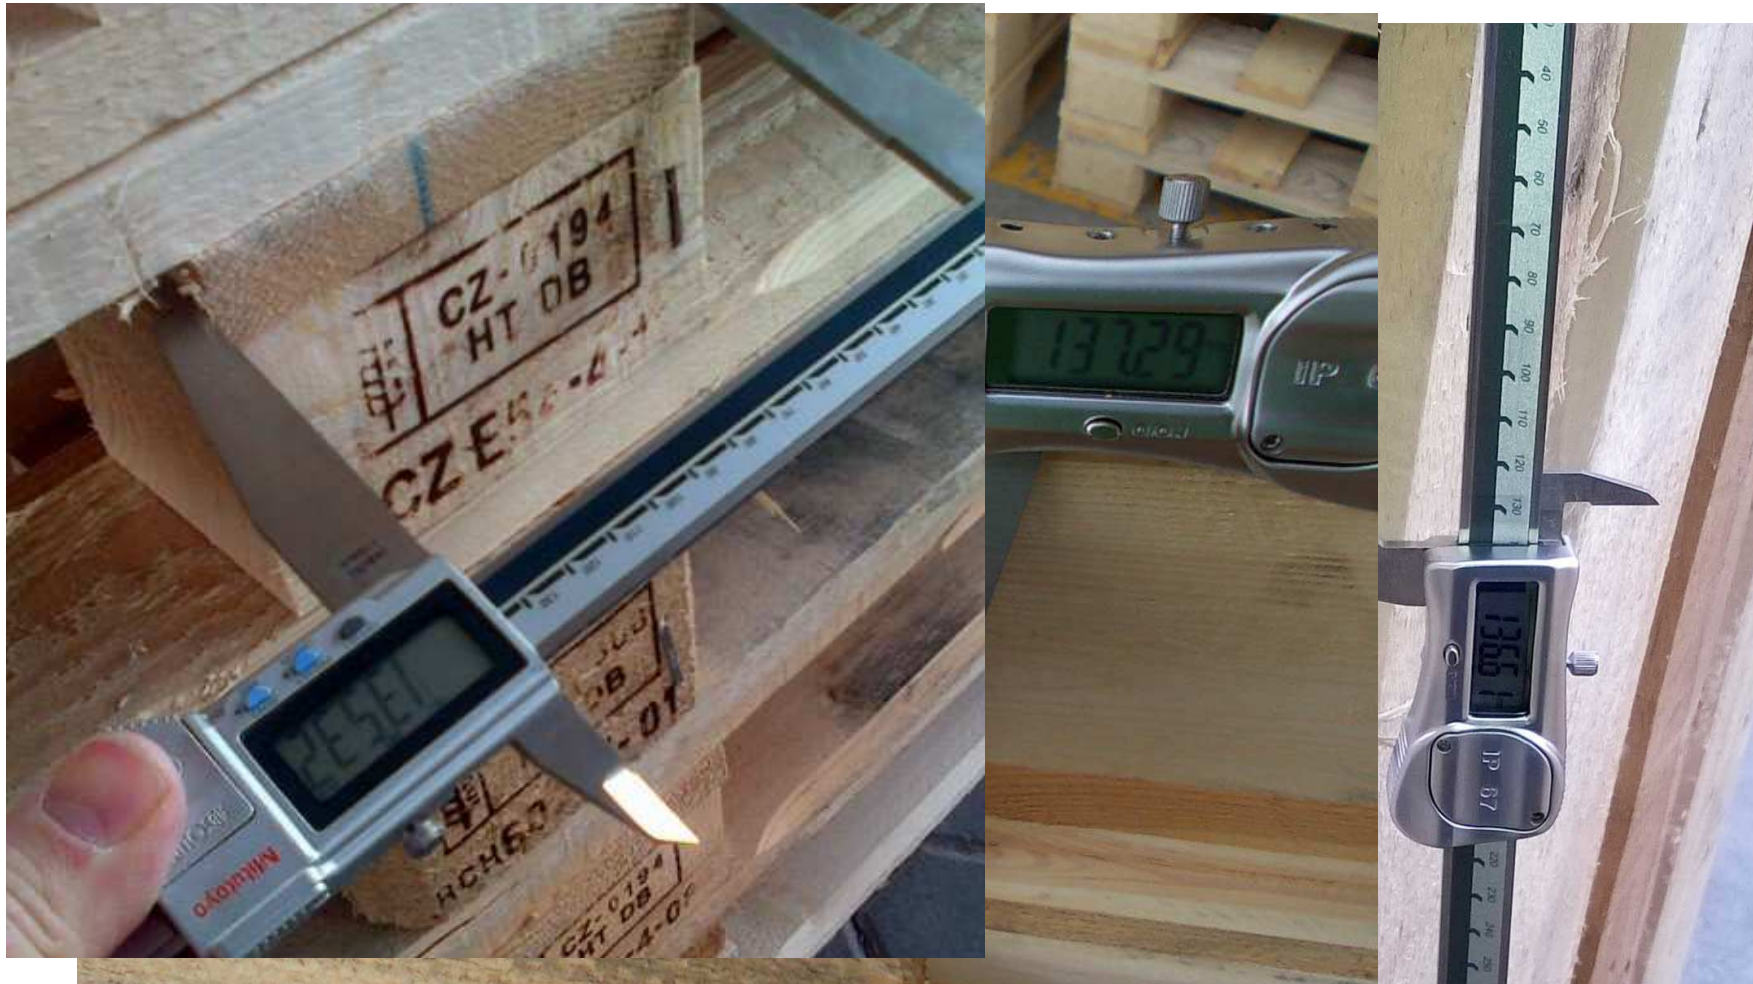
**Tolerable cross board width up to 143 mm**

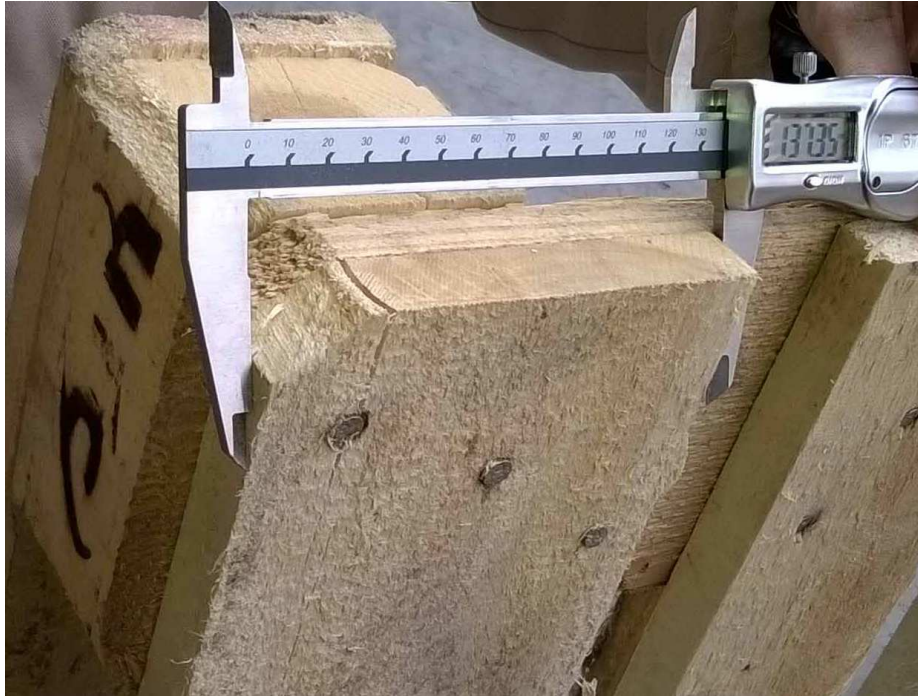
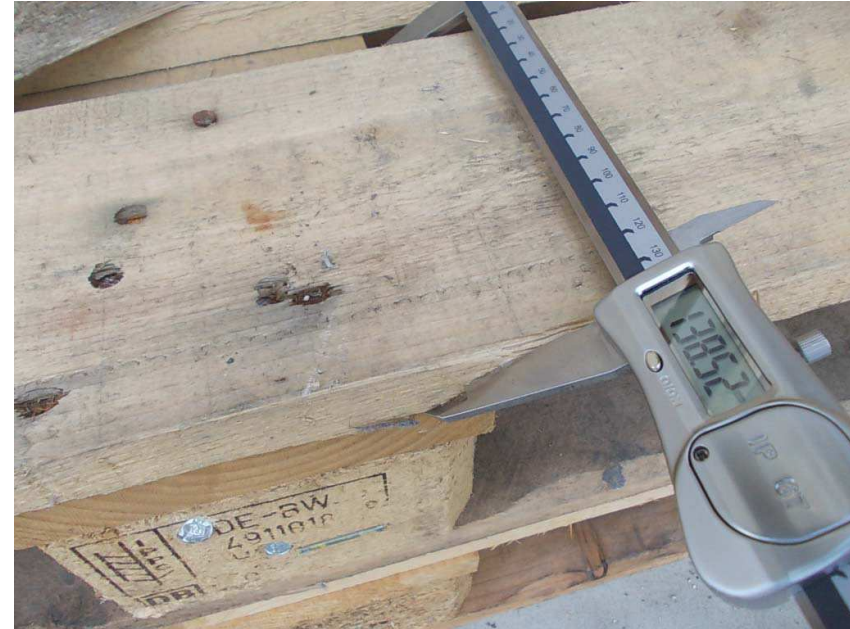
**Tolerable board width up to 143 mm**
